**Evaluation of Corrosion Resistance of New and Upcoming Post-Tensioning  
Materials After Long-Term Exposure Testing**

**Thesis**

The University of Texas at Austin

**December 2010**

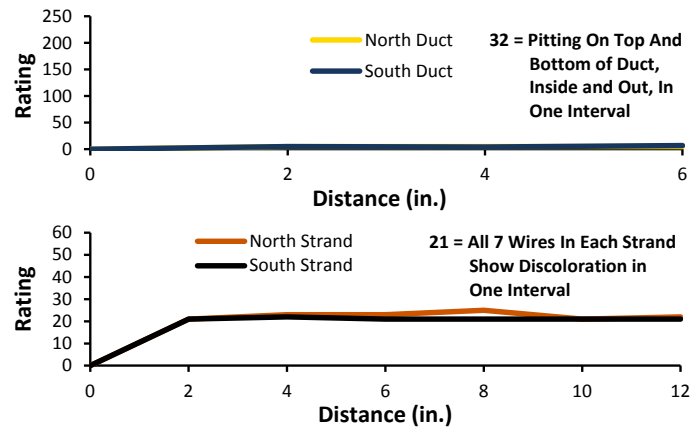
**Figure 5.41: Specimen 1.2 Anchorage Corrosion Rating Plots**

Unlike prior specimens, the ducts were not connected with duct tape to the anchorages<sup>7</sup>. The north duct experienced light localized corrosion on its top outside surface, which had been in contact with the anchorage. Elsewhere, the duct showed localized discoloration. The south duct was slightly more damaged, showing more widespread light corrosion at the end which was spliced into the anchorage. Discoloration on the bottom of both ducts was somewhat dark with undisturbed spots, just as the main autopsy region ducts had appeared. The upper portions of both ducts also showed evidence of small voids which had formed within the top flutes of the ducts. North and south anchorage zone ducts are shown in Figure 5.42. Corrosion ratings for the anchorage zone ducts are shown in Figure 5.41 and summarized in

Discoloration on the anchorage zone strands was not as uniform as in the main autopsy region. The black patina was intermittent over most of each anchorage zone strand. Multi-colored staining and some extremely localized corrosion were found in the wedge region. This suggests that the wedges may have damaged the copper coating and exposed the regular steel below. Damage to the inner wires was comparable to that of the outer wires for all strands. All wedges were found to be intact. The appearance of a typical strand, with and without wedges, is

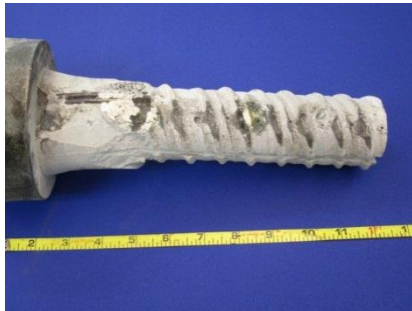
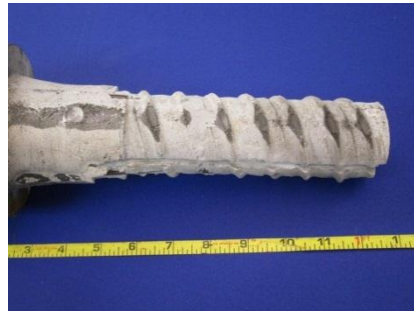
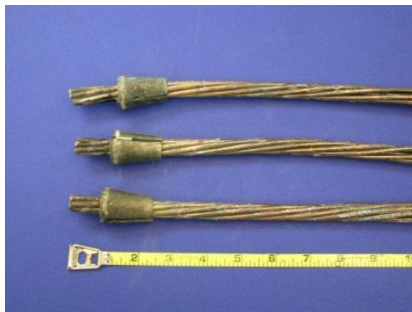
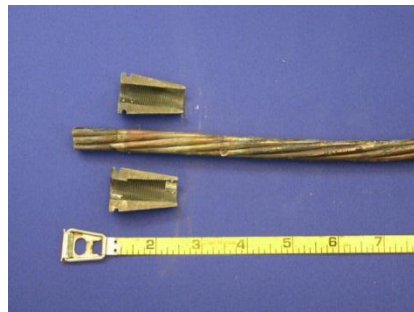
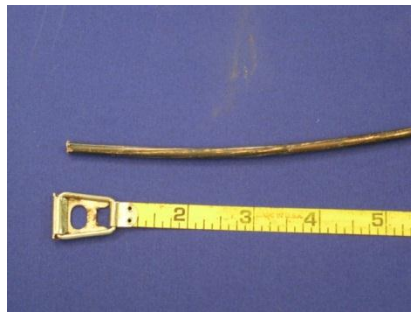
**Figure 5.42: Specimen 1.2 Anchorage Region Elements**

The north tendon anchorage zone grout did not appear to be cracked. There were small voids present corresponding to the locations of the uppermost flutes of the corrugated duct. These voids had a dark gray color, matching the color of the voids near the dead end of the main autopsy region north duct grout. Some very faint flecks of discoloration were found. The north grout itself did not show any discernible color variation. The south grout appeared almost identical to the north duct grout. However, it did show some variation in color. The grout was white-gray at the anchor head and became somewhat darker gray towards the specimen interior. North and south grouts are shown in Figure 5.42.

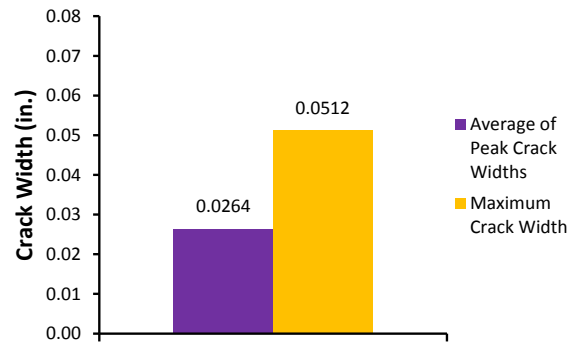
**Figure 5.45: Specimen 2.2 Crack Data**

Three primary transverse cracks crossed the top of the specimen and extended down its north and south faces. The epoxy used on the side faces to seal these cracks against leakage had begun to detach from the concrete at the time of autopsy. Together, the three transverse cracks had an average width of 0.035 inches. Two longitudinal cracks originated from the transverse crack nearest the live end, one of which extended fully to the transverse crack at midspan. Three more extended inward from the dead end transverse crack. These cracks tended to meander somewhat. One of the latter longitudinal cracks turned 90 degrees over its length to become transverse. The average width of the longitudinal cracks was 0.015 inches. Cracks were found extending from the reentrant corner of both the live and dead end corbels around the respective end faces of the specimen. These cracks were not sealed with mortar and were found to be leaking water at the time of autopsy. On the live end of the specimen, the corbel cracks passed through the joint between the anchorage pourback and the rest of the specimen. Some separation occurred along the construction joint as a result. Crack width data is shown in Figure 5.45, and the crack diagram is shown in Figure 5.48.

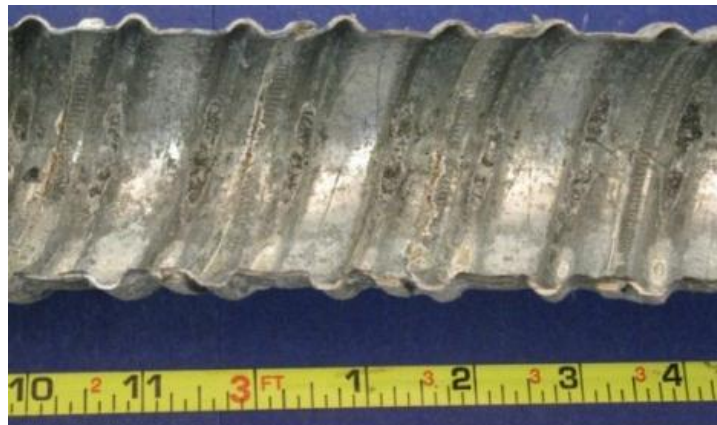
Damage to the south duct was comparable to that of the north duct. Significant area loss occurred within the intervals corresponding to transverse surface cracks. Most intervals which did not experience area loss were only discolored or lightly corroded, both inside and out (see Figure 5.47). The south duct also had evidence of voids in its upper flutes. The void was deep enough between 8 inches and 20 inches from the live end of the autopsy region that the duct flutes did not isolate it. It became one continuous void. In addition, there was prominent orange discoloration around the edges of this void. On the bottom portion of the south duct, much less severe area loss occurred at the same locations as on the top portion. In general, outside corrosion damage was more localized but also more severe than the inside of the duct on the bottom portion. Variations in the discoloration on the inside of the duct indicated that the grout was cracked (see Figure 5.46). Duct corrosion ratings are shown in Figure 5.48 and summarized in Table 5.11.

***Figure 5.46: Specimen 2.2, Discoloration Inside South Duct Showing Signs of Cracked Grout***

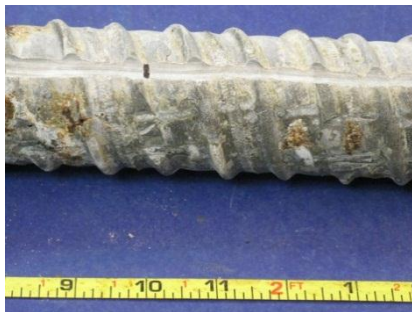
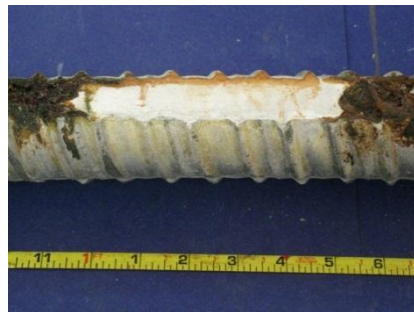
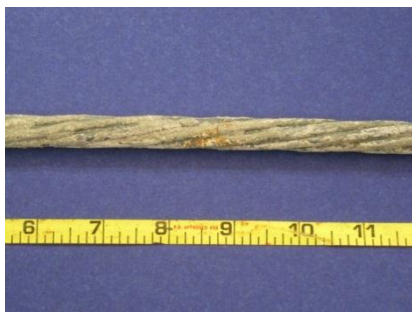
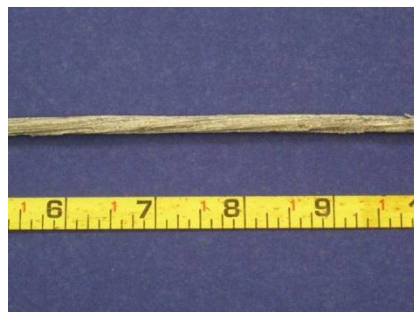
**Figure 5.47: Specimen 2.2 Main Autopsy Region Elements**

The north longitudinal bar was considerably more damaged than the south bar. The north bar experienced moderate corrosion and staining on over half its length. The severity was generally greater at locations where stirrups were tied or a transverse surface crack was present. This is shown in Figure 5.47. The south bar only showed this degree of corrosion on the intervals where stirrups had been tied. This corrosion could not be removed with a scouring pad. On all other intervals, the south bar had either light localized corrosion or discoloration. Overall, corrosion ratings were highest for both bars in the vicinity of the transverse crack near the dead end of the autopsy region. Longitudinal bar corrosion ratings are shown in Figure 5.48 and summarized in Table 5.11.

The stirrups also experienced moderate but consistent damage. All but one of the stirrups had corrosion over at least one interval which could not be removed with a scouring pad. However, only two stirrups experienced pitting on any interval. Corrosion and discoloration were most prevalent at the stirrups' bend locations and the locations where the ducts were tied (see Figure 5.47). The three most severely damaged stirrups were the ones located beneath each of the specimen's transverse surface cracks. Stirrup corrosion ratings are shown in Figure 5.48 and summarized in Table 5.11.

transverse surface cracks (see Figure 5.47). However, this damage was extremely concentrated. Most of the other intervals of the duct, inside and out, showed only localized light corrosion or discoloration. The inside of the duct had evidence of small voids in its uppermost flutes. The outside bottom portion of the north duct experienced substantial localized pitting at midspan and its quarter points, as well as some slight area loss at midspan. Damage was similar inside the bottom portion. However, the corrosion was at once less severe and more widespread. Overall, the highest corrosion ratings for the north duct occurred at midspan.

The north tendon grout was cracked transversely every few inches along its entire length. Small voids, approximately 0.5 inches across, were found along the length of the grout. All of them appeared to be isolated from each other by the top flutes of the duct. Significant staining was present in the areas corresponding to duct corrosion and area loss. This staining seeped down the grout through its transverse cracks, though not to the level of the strands. Localized yellow-brown discoloration was observed over nearly the entire length of the grout. Some segregation was observed in the form of color variation from white to dark gray, both over the height of the grout as well as within the duct flutes on its underside. This is shown in Figure 5.47. The grout appeared not to have consolidated well around the lowest strands in the tendon. At least one strand was partially exposed over much of the duct's length. Maximum chloride concentration in the grout was 0.084%, occurring 20 inches from the live end. Elsewhere in the north grout, the chloride levels were at or just above the corrosion threshold.

The south tendon grout was similar in appearance to the north tendon grout. A large, continuous void was present from about 8 inches to about 20 inches from the live end. This void was approximately 1 inch wide. Smaller voids, restricted to 0.5 inches in width or less by the upper flutes in the duct, were present over the rest of the grout's length (see Figure 5.47). Extensive corrosion staining was found corresponding to the regions of the duct which experienced the most severe corrosion and area loss. Like the north duct, this staining seeped downward through the grout's transverse cracks. Localized light yellow discoloration was present along the length of the grout, mostly on its bottom portion. The maximum chloride content of 0.43% occurred 18 inches from the live end of the grout. Beneath the live end transverse surface crack, the chloride concentration was 0.14%. Beneath the dead end crack, chloride levels were just above the corrosion threshold. Chloride content for grout in both ducts is given in Figure 5.48.

The north tendon strands suffered only minor damage. The outer wires of each strand had no corrosion or discoloration whatsoever in many intervals, and the inner wires had localized discoloration at worst. A few miniscule specks of corrosion were found at midspan on one strand and at midspan and the dead end quarter point of another. Although small, these specks could not be removed with a scouring pad. Corrosion ratings were highest for the north duct strands at the locations corresponding to the specimen's live end and midspan transverse surface cracks.

Damage to the south tendon strands was comparable to the north duct strands. Damage was generally mild on all wires, although small, nonremovable flecks of corrosion were present beneath the live end transverse crack on one strand and beneath the dead end transverse crack on another strand. Light surface corrosion was also more present near these critical locations than elsewhere on the strands. The inner wire of each strand was slightly more discolored or corroded than its corresponding outer wires, but only marginally so. The highest corrosion rating for the south duct strands occurred beneath the dead end transverse surface crack on top of the specimen. A typical strand and inner wire are shown in Figure 5.47. Strand corrosion ratings are shown in Figure 5.48 and summarized in Table 5.11.

The galvanized strand in this specimen had a much stronger bond with the surrounding grout than any type of strand seen thus far. Overall, grout was very difficult to remove from the strands in both tendons. In general, corrosion and discoloration appeared on the zinc coating of the outer wires in each strand. On the other hand, corrosion occurred mostly on the bare steel of the inner wire of each strand, which was exposed due to the galvanizing process occurring after the strands were wound.

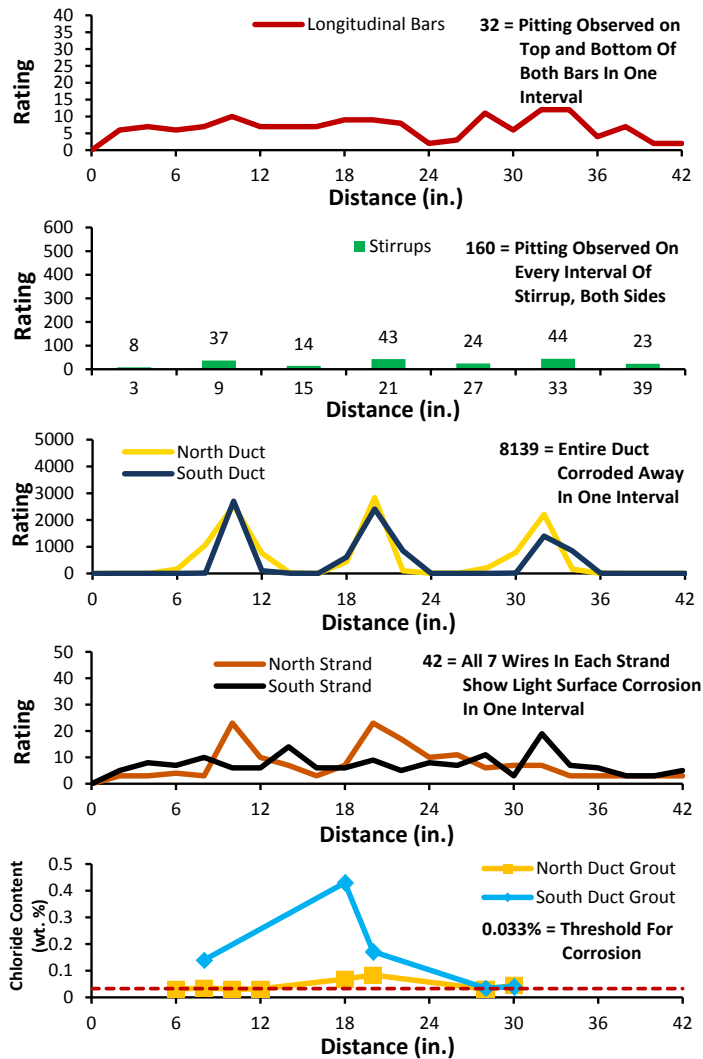
Figure 5.48: Specimen 2.2 Crack Map and Corrosion Rating Plots

Grout chloride contents were higher at every measured point on the live end half of the south tendon than the same region of the north tendon. This occurred in spite of similar area loss in the north and south ducts. The higher chloride content in the south tendon may be due to the accumulation of corrosion products around the large, extensively stained void on its live end half. Concentrations were nearly equal on the dead end half of both tendons and much lower than the chloride contents on the live end half of each tendon. The lower chloride contents suggest that

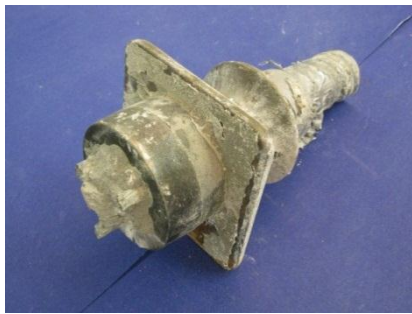
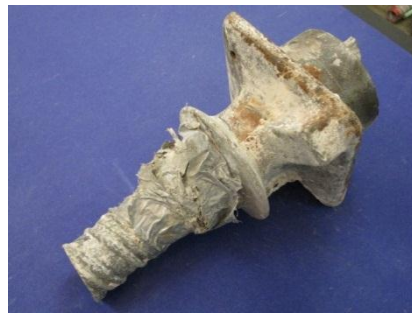
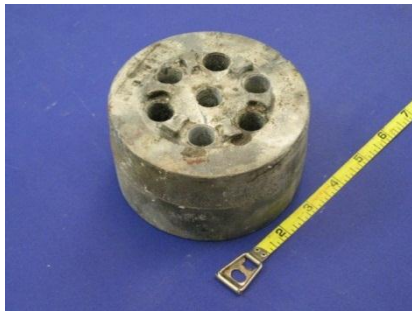
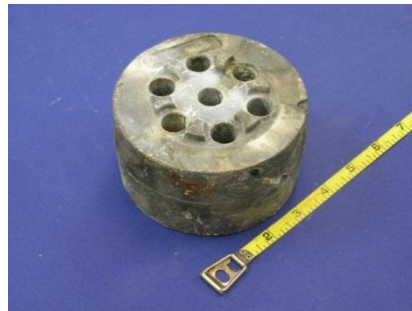
***Figure 5.49: Specimen 2.2 Anchorages and Anchor Heads***

After extraction, the epoxy used to seal the exposed surfaces of the anchorages was only partially intact on the bearing plates. The anchor heads were fully exposed. The north bearing plate showed localized spots of moderate corrosion near the bottom of its exposed area and on the surfaces against which concrete was cast. Most of this corrosion occurred on the bottom surface. The south bearing plate experienced similar damage, although the moderate corrosion was somewhat less widespread on both its exposed surface and on the bottom of the surface which had been cast against. The duct tape used to connect the ducts to the bearing plates was somewhat ripped but mostly intact. Both anchor heads experienced some localized moderate corrosion on their side and inside faces. North and south anchorages and anchor heads are shown in Figure 5.49.

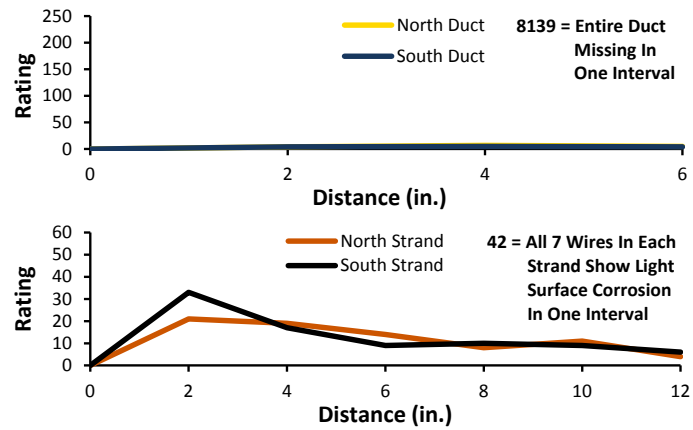
*Figure 5.50: Specimen 2.2 Anchorage Corrosion Rating Plots*

Both the north and south anchorage zone ducts experienced very mild corrosion damage. On the outside of the ducts, some light localized corrosion was found in the areas which had been covered by duct tape. Inside, the ducts showed evidence of small voids within their top flutes. Some light corrosion spots were found in some of these voids. All duct surfaces showed widespread discoloration over all intervals. Lines visible in this discoloration suggest that the grout was cracked transversely. North and south ducts are shown in Figure 5.51. Anchorage zone duct corrosion ratings are shown in Figure 5.50 and summarized in Table 5.12.

Typical strands, with and without wedges, are shown in Figure 5.51. Anchorage zone strand corrosion ratings are shown in Figure 5.50 and summarized in Table 5.12.

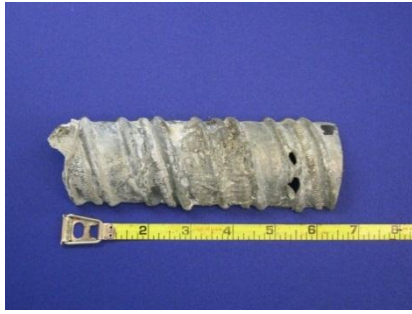
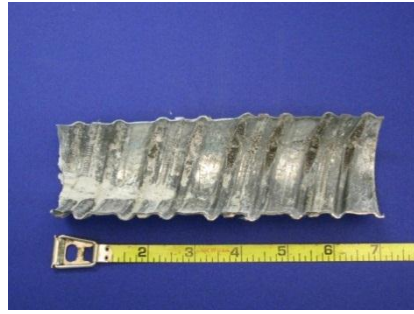
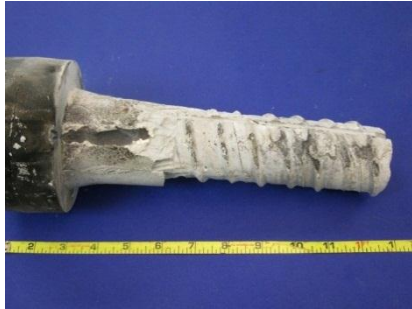
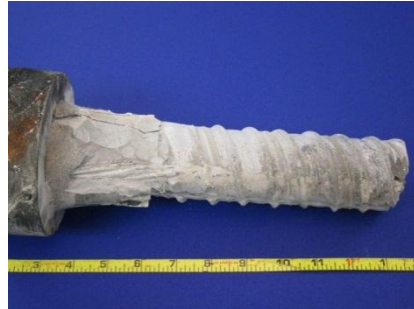
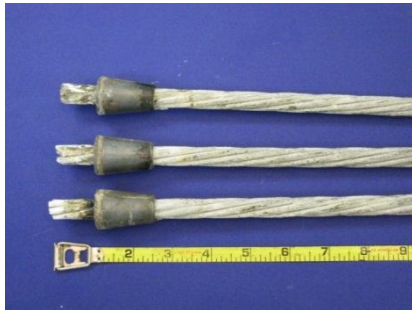
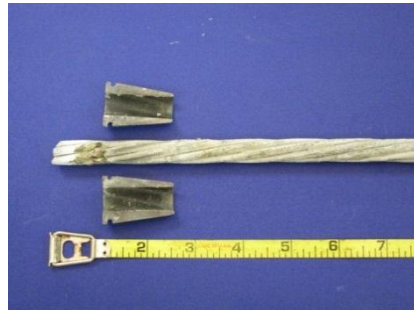
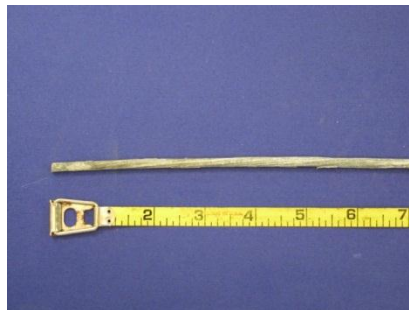
**Figure 5.51: Specimen 2.2 Anchorage Region Elements**

The north and south tendon grouts appeared almost identical. Both grouts had several small voids on their top side corresponding to the upper flutes of the duct. Some extremely localized staining was found on the grout areas which had been within the anchorages. The grouts' color varied from white near the anchor heads to gray further within the specimen. This indicates that some segregation may have taken place, resulting in density variation. Two strands were visible on the surface of each grout near the anchor head. It appears that these strands were in direct contact with their respective anchorages in that region. North and south grouts are shown in Figure 5.51.

In the anchorage zone, all strands were found to have an extremely strong bond with the surrounding grout, just as was observed in the main autopsy region. Damage to all anchorage zone strands was limited to discoloration or light surface corrosion for all wires in all intervals. In general, the inner and outer wires of each strand were uniform in appearance. However, on two strands in the north tendon and one in the south tendon, damage was much less severe on the inner wires than the outer wires. For all strands, discoloration was most pronounced at the locations where the wedges had been applied. Corrosion ratings were also highest over that interval for the strands in both ducts. All wedges were found to be intact. Some localized light corrosion was found on their exteriors as well as slight discoloration in their inner regions.

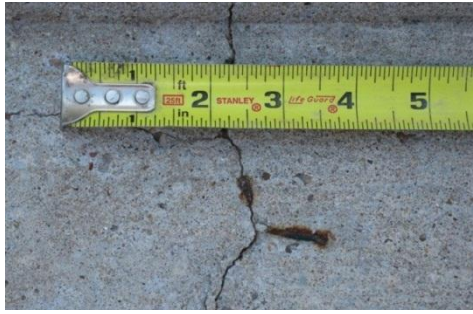
Light to moderate scaling was found on much of the top and north and south faces of the specimen. This was most pronounced in the raised edges surrounding the saltwater tray. A few small surface air voids were visible on the surfaces of the specimen, but to a much lesser extent than seen in previous specimens. Light to moderate spalling was visible around the specimen's transverse cracks, especially toward the middle of the specimen. The top of a corroded wire tie was visible through the surface of the concrete just toward the live end from the north grout vent. This is shown in Figure 5.53.

**Figure 5.53: Specimen 2.4, Corroded Wire Tie at Top Surface**

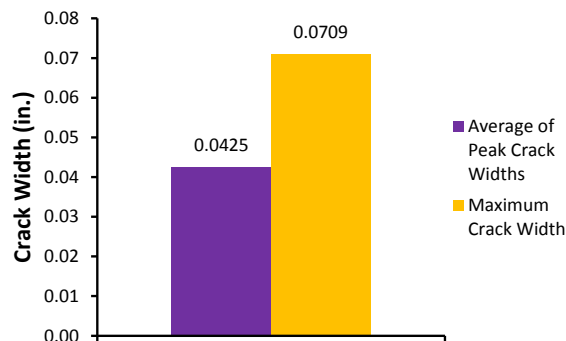
**Figure 5.54: Specimen 2.4 Crack Data**

The specimen had three main transverse cracks which extended across its top face and down its north and south faces. The epoxy applied to those cracks on the side faces to prevent leakage was still intact. These transverse cracks had an average width of 0.04 inches. Two secondary transverse cracks were also visible. These did not cross the entire specimen and had an average width of 0.035 inches. Two longitudinal cracks were found which connected the two transverse cracks nearest to the specimen's live end. The average width of these cracks was 0.015 inches. Most of the cracks on the specimen had more than one branch. Overall, the top of this specimen was the most cracked of any seen up to this point. Cracks were observed extending from the re-entrant corner of both corbels and around both end faces of the specimen. On the live end, this cracking occurred during live load application, and the cracks had been sealed with non-shrink mortar. On the dead end, the cracking occurred some time later. These cracks had not been sealed (see Figure 5.52). Some light efflorescence was observed around the dead end corbel cracks, indicating that leakage may have taken place at an earlier time. Crack width data is shown in Figure 5.54, and the crack diagram is shown in Figure 5.58.

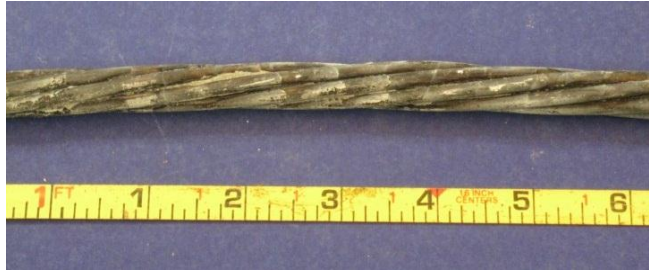
wires, the patina could generally be removed with a scouring pad. This was not the case for the inner wires. Transverse lines were visible in the traces of grout near midspan of all strands. These lines indicated the locations of cracks in the surrounding grout (see Figure 5.56). Unlike specimen 1.2, no signs of dezincification were found. Strand corrosion ratings are shown in Figure 5.58 and summarized in Table 5.13.

***Figure 5.56: Specimen 2.4, Lines in Strand Discoloration***

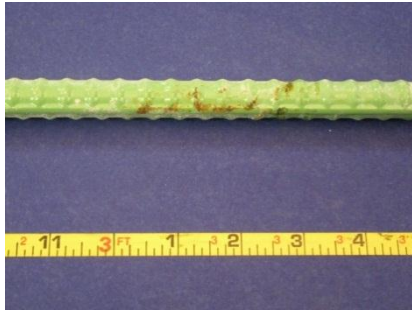
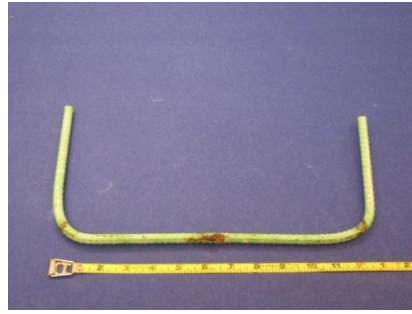
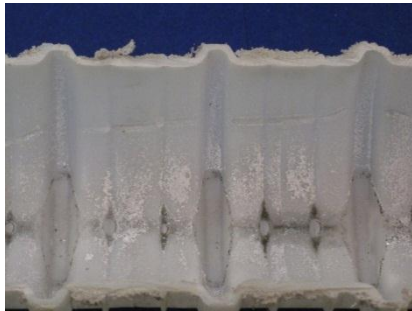
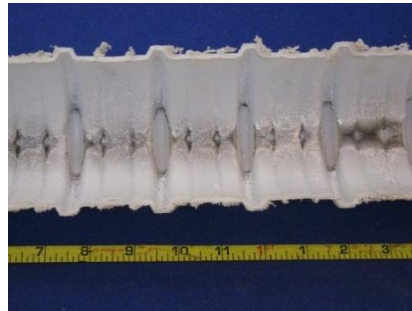
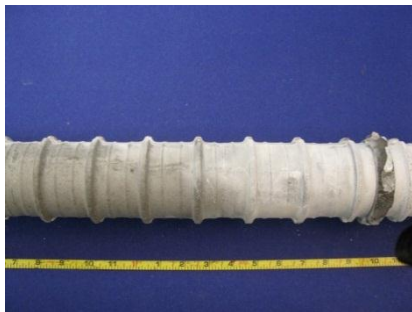
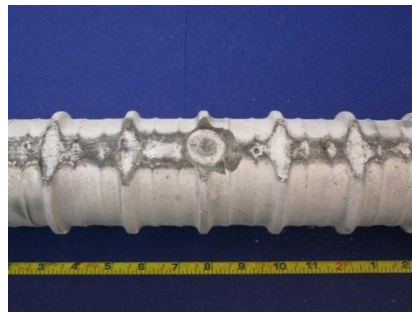
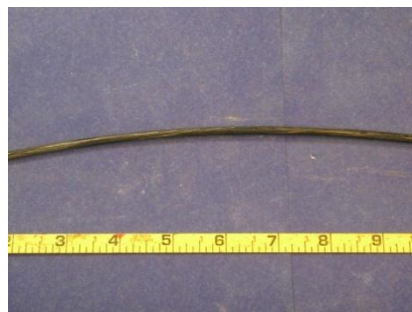
**Figure 5.57: Specimen 2.4 Main Autopsy Region Elements**

Damage to the north and south longitudinal bars was moderate and localized. The north bar showed light to moderate corrosion at the locations where stirrups were tied, and some light corrosion staining at other points along its length (see Figure 5.57). Damage was more severe to the underside of the bar than to the top. The extent of corrosion was similar in the south bar, although somewhat more severe. Localized pitting was observed over one interval near the live end of the bar. Longitudinal bar corrosion ratings are shown in Figure 5.58 and summarized in Table 5.13.

Stirrups in this specimen were moderately damaged. Six of the seven stirrups had moderate corrosion or pitting over at least one interval. The worst damage tended to occur at the bend points of the stirrups and at locations where ducts were tied. However, pitting occurred over at least one interval at midspan of three stirrups' horizontal portions. This suggests that damage to the epoxy coating may have occurred at these locations. Stirrup #5 suffered the heaviest damage. This stirrup lost over 20% of its cross sectional area over a small length at midspan of its horizontal portion (see Figure 5.57). Damage did not correspond clearly to surface crack location. Although stirrup #5 was located beneath a transverse surface crack, corrosion ratings for the other six stirrups were relatively independent of location. Stirrup corrosion ratings are shown in Figure 5.58 and summarized in Table 5.13.

The north and south plastic ducts were in near-perfect shape upon autopsy. The top of the inside of the north duct had scratches along approximately 36 inches of its length. These scratches had a depth of between 5 and 10 percent of the duct's wall thickness (see Figure 5.57). The top of the inside of the south duct was similarly damaged, although the scratches were shallower and shorter in length. The top of both ducts also showed evidence of voids which had formed inside their top flutes. The voids did not appear to be connected, and they were all approximately uniform in size and shape (see Figure 5.57). Small white crystals were found in the immediate vicinity of these voids over most of the ducts' length, but most conspicuously near midspan. A dull white residue was found on the outside of both ducts. This was more randomly distributed over the duct's length than the crystals. There were also a few localized corrosion stains on the outside of the ducts. White crystals were present over nearly the entirety of the

The north tendon grout was cracked transversely every few inches along its entire length. One longitudinal crack was visible on the underside of the grout. This crack appeared to terminate within approximately 6 inches of each end of the grout. Small voids, approximately 1 inch across, were found on the top surface of the grout, corresponding to the upper flutes of the duct. These voids were dark gray in color near the ends of the grout and became whiter toward midspan. A similar color change was observed in the grout itself from ends to midspan (see Figure 5.57). This may be evidence of segregation, and therefore density variation, within the

The south tendon grout was also cracked every few inches along its length. One longitudinal crack was observed at roughly midheight of the grout. This crack extended along the grout's entire length. Small voids were observed on the grout's upper surface. These voids were comparable in size to those found in the north grout. While these voids were mostly bounded by the upper flutes of the duct, they appeared to be slightly deeper and, as a result, more continuous than the voids in the north duct (see Figure 5.57). No color change indicating the possibility of segregation was observed. While intact, this grout was much smoother to the touch over its entire exposed surface than any grout encountered thus far. This may indicate that pressure was high and uniform during the grouting process. One strand was exposed on the underside of the grout from approximately 16 inches to 24 inches from the live end. Chloride concentration at midspan was 0.25% in the south duct. Chloride content for grout in both ducts is shown in Figure 5.58.

A uniform, glossy black patina was observed over every interval of every wire in every strand of the specimen. The patina was much glossier and somewhat darker on the inner wires than the outer wires. At the ends of each strand, the patina was less prevalent, and traces of the original copper color were visible in many spots. This can be seen in Figure 5.57. On the outer

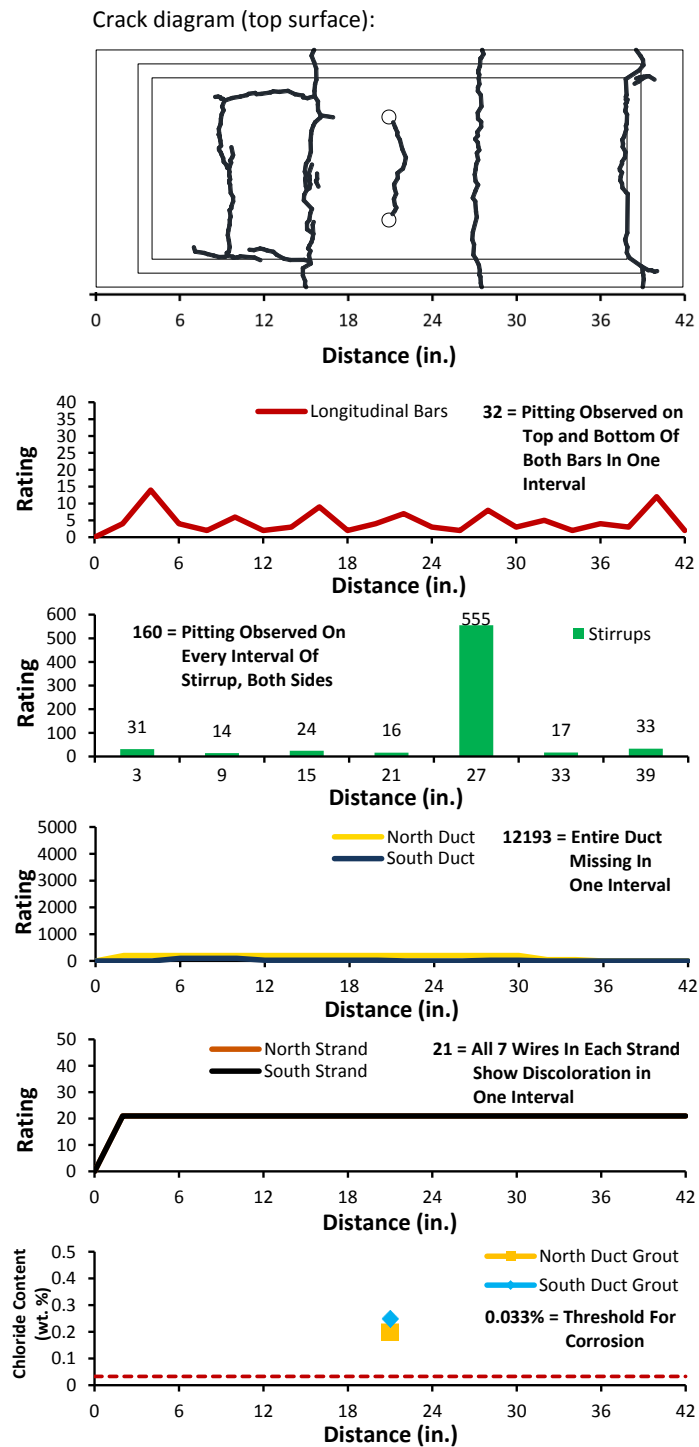
Figure 5.58: Specimen 2.4 Crack Map and Corrosion/Damage Rating Plots

The chloride content at midspan of the grout in each tendon was well above the corrosion threshold despite the lack of any meaningful damage to the ducts themselves. The coupler also showed no signs of a breach. Thus, the chlorides could not have entered through either the duct or coupler. Similarly, there was no evidence to suggest that chlorides entered through the anchorage region on either end of the specimen. The only remaining means of chloride ingress would be the grout vent located at midspan of the south tendon and on top of the coupler located at midspan on the north tendon. The detached epoxy at the south duct grout vent supports the idea that chlorides entered the duct at a central location on the tendon. Chlorides entered through small imperfections in the grout vent-duct or grout vent-coupler interface and penetrated the grout through its transverse cracks. Because the copper-clad strand was uniform in appearance over the entire length of both tendons, it appears that the chlorides traveled along the tendons through the strand interstices, as well.

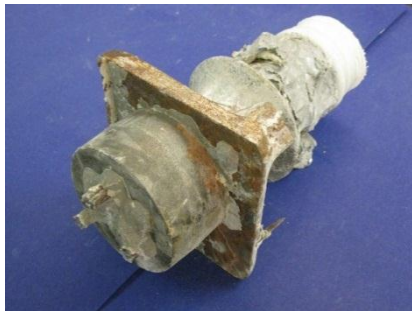
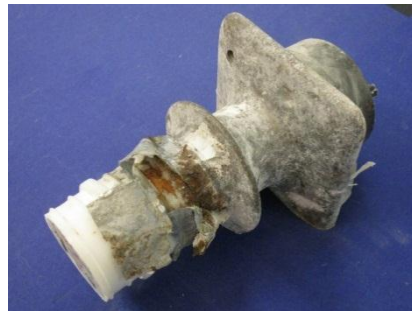
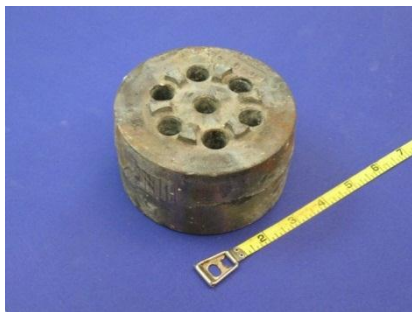
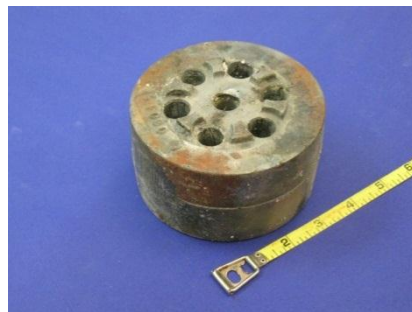
***Figure 5.59: Specimen 2.4 Anchorages and Anchor Heads***

The epoxy used to seal the exposed faces of the anchorages was almost entirely stripped away. Only small portions of the epoxy still adhered to the anchorages. The exposed face of the north bearing plate showed extensive light to moderate corrosion. The exposed face of the south bearing plate was much less affected. The undersides and outer edges of both bearing plates had moderate surface corrosion. The bottom 1 inch of each bearing plate was inadvertently sliced off by the concrete saw during autopsy. Therefore, the extent of corrosion could not be determined there. The duct tape used to seal the anchorage zone ducts was partially missing on both anchorages. Widespread moderate surface corrosion and some pitting were visible in the splice region. Both anchor heads showed patches of light to moderate corrosion, mostly concentrated around the anchor head-bearing plate interface. North and south anchorages and anchor heads are shown in Figure 5.59.

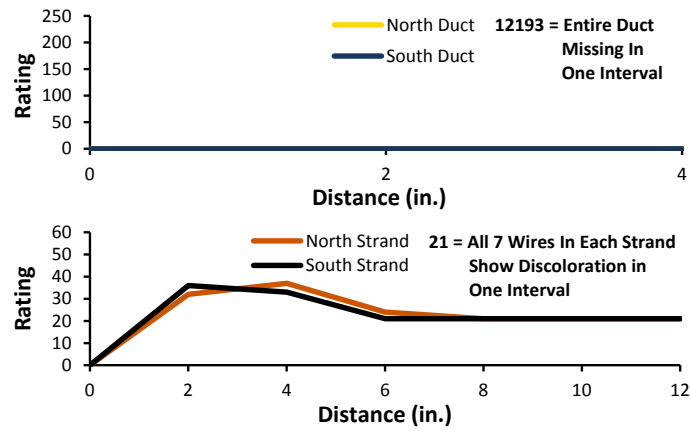
*Figure 5.60: Specimen 2.4 Anchorage Corrosion/Damage Ratings*

Both anchorage zone ducts showed evidence of voids in their upper flutes, as well as traces of the same white crystals found in the ducts of the main autopsy region. In addition, the outside of the ducts were covered with traces of the same chalky white residue which had been found on the outside of the ducts in the main autopsy region. Moderate to severe corrosion staining was found along the inside and outside rims of the end of the ducts which had been spliced to the anchorages. North and south anchorage zone ducts are shown in Figure 5.61. No scratches or gouges were found inside the ducts. Anchorage zone duct corrosion ratings are shown in Figure 5.60 and summarized in Table 5.14.

Within the first four inches from the end of the specimen of all six strands, the distinctive green color of corroding copper was visible in very localized spots. No sign of steel corrosion was found in this region on any strand. Moving in toward the specimen interior, the same patina which covered the strands in the main autopsy region was found, although the patina covered much less of the strands' overall area. Two of the specimen's dead end wedges were cracked, and some spots of moderate corrosion were found on both the inside and outside surfaces of all six wedges. Typical strands, with and without wedges, are shown in Figure 5.61. Anchorage zone strand corrosion ratings are shown in Figure 5.60 and summarized in Table 5.14.

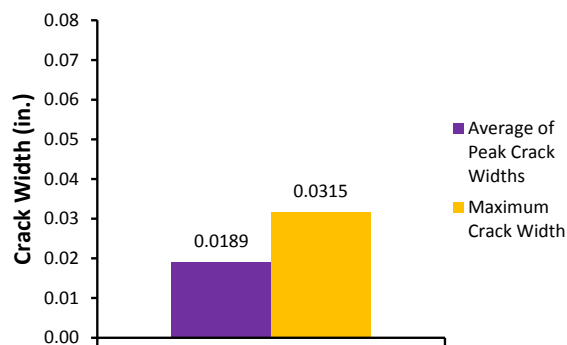
**Figure 5.64: Specimen 3.1 Crack Data**

The top surface of the specimen was extensively cracked. Three transverse cracks crossed the top of the specimen and extended down its north and south faces. The epoxy used to seal these cracks was intact at the time of autopsy. The transverse cracks had an average width of 0.02 inches. Two longitudinal cracks extended along almost the entire length of the autopsy region and were located approximately 4 inches from the north and south faces of the specimen, respectively. These cracks had an average width of 0.006 inches. Cracks were found on both ends of the specimen which extended nearly to the corbels there. These cracks had occurred some time after stressing and were not sealed with mortar. Efflorescence and moisture were found in the vicinity of the cracks, indicating that leakage had occurred there (see Figure 5.63). The efflorescence was slightly more extensive around the dead end cracks. Crack width data are shown in Figure 5.64, and the crack diagram is shown in Figure 5.68.

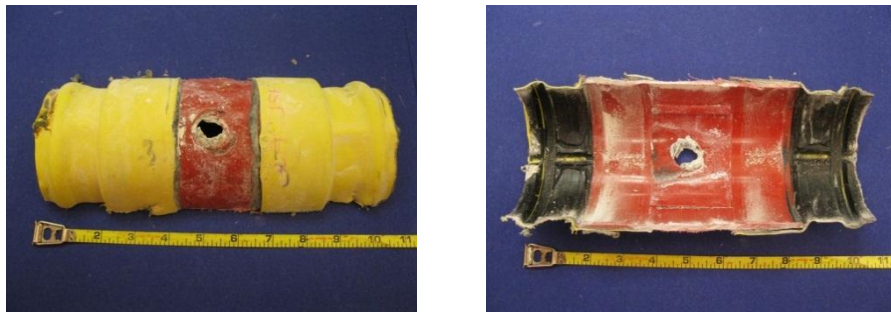
***Figure 5.65: Specimen 3.1 North Duct Coupler Outer Surface (Left) and Inner Surface (Right)***

The heat shrink coupler applied to the north duct was mostly intact at the time of autopsy. Both the inside and outside surfaces of the coupler showed similar discoloration and evidence of more voids than what was observed on the north duct itself. The seam between the dead end heat shrink and the coupler appeared somewhat detached around its entire circumference. This may have occurred during the autopsy process. The heat shrink tubing was somewhat brittle and easy to peel back from the duct surface. There may not have been a perfect heat shrink seal around both ducts. The coupler is pictured in Figure 5.65.

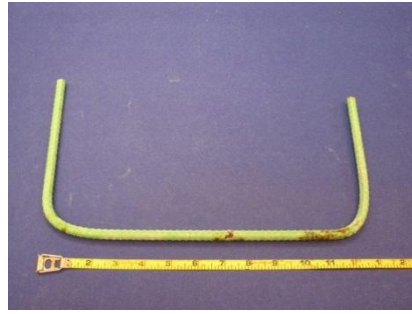
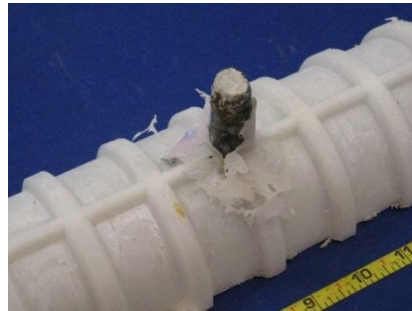
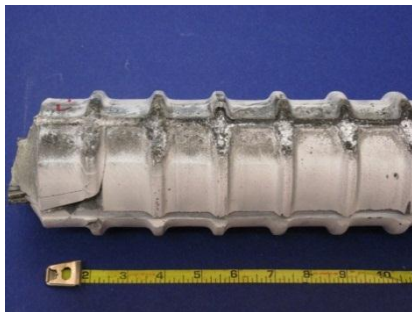
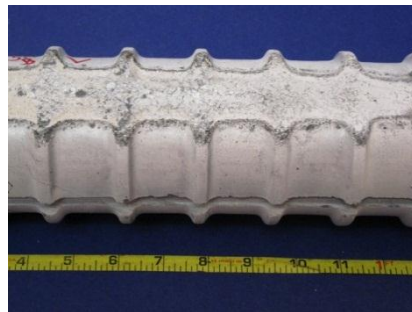
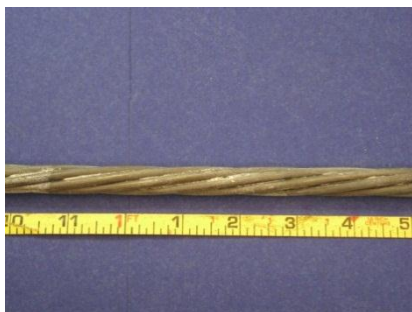
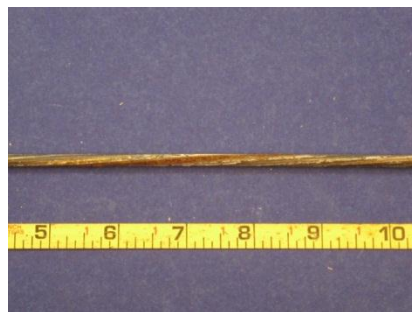
**Figure 5.67: Specimen 3.1 Main Autopsy Region Elements**

Both the north and south longitudinal bars showed only minor corrosion damage. The north bar experienced corrosion which could not be scrubbed away on two intervals. Otherwise, damage was limited to light discoloration and corrosion which occurred mostly at the locations where stirrups had been tied, as shown in Figure 5.67. In general, the north bar was more corroded than the south bar, and corrosion ratings for both bars were highest underneath the location of the specimen's transverse surface cracks. Longitudinal bar corrosion ratings are shown in Figure 5.68 and summarized in Table 5.15.

longitudinal rib, the voids were continuous over most of the duct's length. The epoxy which sealed the grout vent at midspan appeared to have detached from the duct somewhat. It is unknown whether this occurred during autopsy or some time before (see Figure 5.67). The bottom interior portion of the duct had some light gouges between midspan and the dead end. It appeared that one strand had been bearing directly on the duct there. Shiny white crystals were observed in and around the bottom flutes of the duct on its interior. These crystals were more prevalent near midspan than elsewhere inside the duct. Duct damage ratings are shown in Figure 5.68 and summarized in Table 5.15.

The north tendon grout had transverse cracks every few inches along its entire length. No longitudinal cracks were observed. Voids, approximately 0.75 inches wide, were observed on the top surface of the grout. These were mostly contained within the transverse flutes of the duct but were connected over most of the grout's length by the top longitudinal rib of the duct (see Figure 5.67). The voids were generally white on their surface with a dark gray or black perimeter. Near

The south tendon strands showed similar damage. The outer wires of all strands showed light localized discoloration. No corrosion spots were found in any intervals. Lines were observed among the discoloration, indicating cracks in the surrounding grout. The inner wires were more damaged than the outer wires in all strands. Many small corrosion flecks were observed along the length of all inner wires. In a few intervals, this corrosion could not be scrubbed away. This occurred near midspan and the dead end of all three strands' inner wires. Corrosion ratings were nearly uniform along the strands' length. No clear correlation with crack location was observed. A typical strand and inner wire are shown in Figure 5.67. Strand corrosion ratings are shown in Figure 5.68 and summarized in Table 5.15.

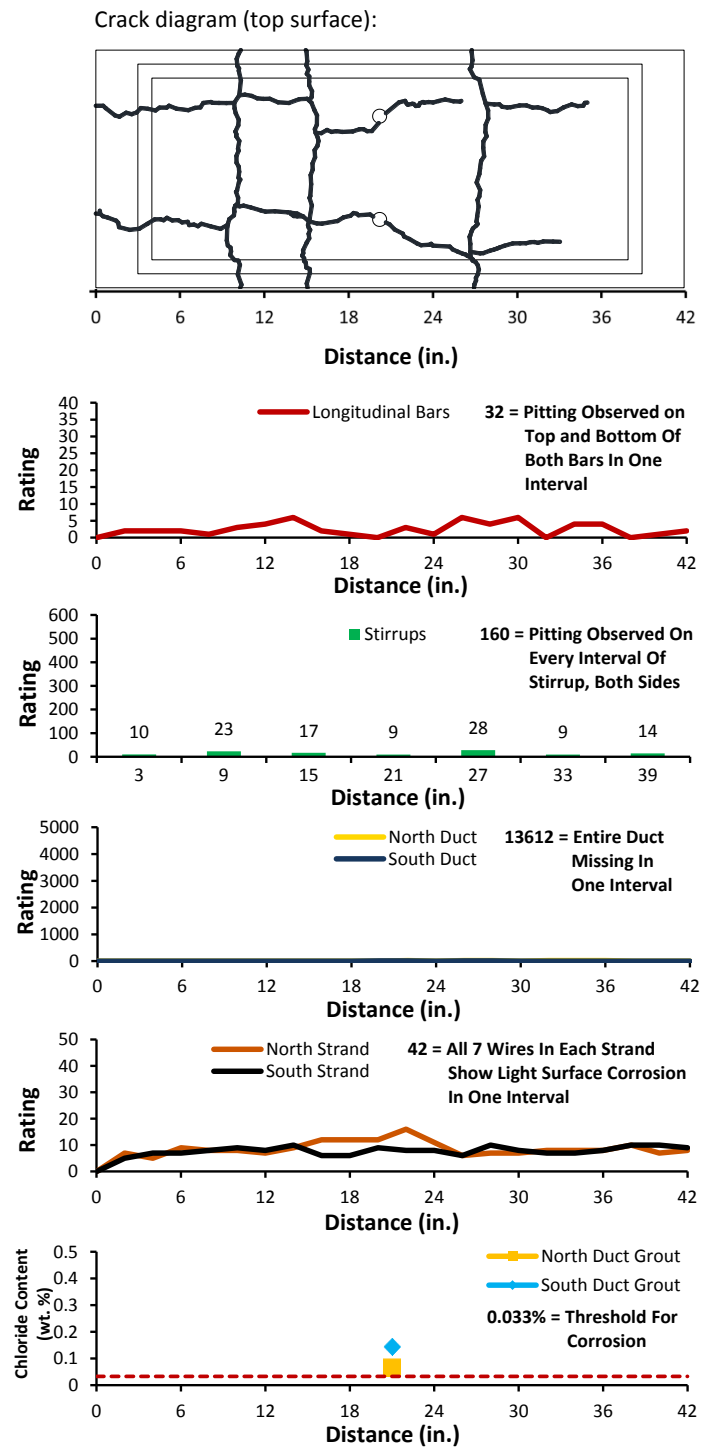
Figure 5.68: Specimen 3.1 Crack Map and Corrosion/Damage Rating Plots

The stirrups showed relatively minor damage. Only two stirrups showed pitting in any interval, and only three stirrups showed surface corrosion which could not be scrubbed away in any interval. Most corrosion and discoloration were observed at the inner and outer surfaces of the stirrups' bend radii, as well as at midspan of their horizontal regions (see Figure 5.67). The stirrups with the highest corrosion ratings were those found directly beneath the specimen's three transverse surface cracks. Stirrup corrosion ratings are shown in Figure 5.68 and summarized in Table 5.15.

The south tendon grout was cracked transversely every few inches along its length. No longitudinal cracks were found. Cracking was more extensive near the dead end than the live end. One continuous void, approximately 1.25 inches wide, was found on the top of the grout extending from the live end to near midspan. The remainder of the grout showed smaller voids, about 0.5 inches across, on its top surface, connected by the top longitudinal rib of the duct. The surface of the large void was white in color with a gray perimeter and many small gray craze cracks. The smaller voids were uniformly gray in color, as shown in Figure 5.67. On the underside, the dead end region was much darker in color than the rest of the grout. This indicates that segregation took place during grouting. One wire of a strand was observed intermittently on the bottom surface of the grout from approximately 18 to 28 inches from the live end. Chloride content at midspan was 0.145%. Chloride content for north and south grouts is shown in Figure 5.68.

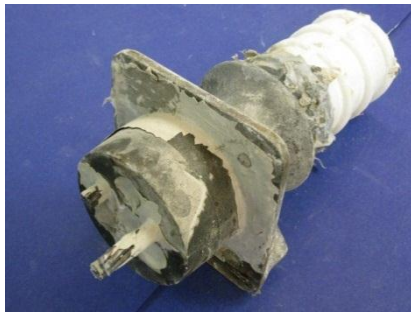
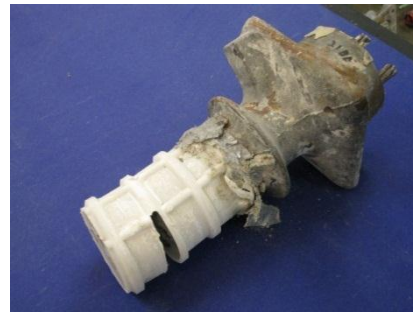
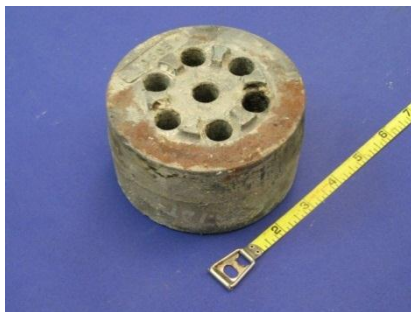
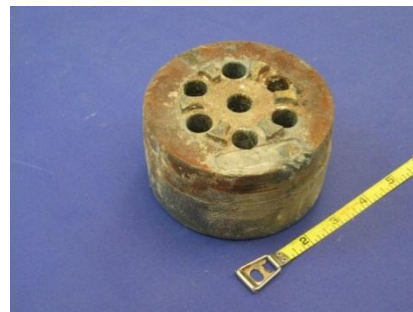
**Figure 5.69: Specimen 3.1 Dead End Anchorages and Anchor Heads**

The epoxy used to seal the exposed areas of the anchorages was mostly intact on the bearing plates, but largely missing on the anchor heads. The exposed surface of the north bearing plate showed widespread moderate surface corrosion, mostly concentrated on the bottom half of the plate. The south bearing plate was much more affected, with moderate corrosion covering most of its outer surface. Extensive surface corrosion was found on the bottom surface of both bearing plates. Although the duct tape used to connect both ducts to the bearing plates was mostly intact, widespread corrosion and pitting were found underneath. This damage was more severe to the south bearing plate than to the north. The outer surfaces of both anchor heads had localized spots of light to moderate surface corrosion. The surfaces which had been bearing on the anchorages showed much more widespread moderate corrosion, corresponding to the respective level of corrosion in both bearing plates. The north and south anchorages and anchor heads are shown in Figure 5.69.

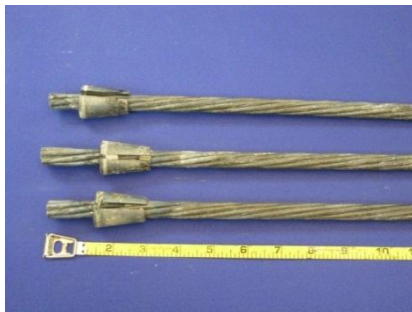
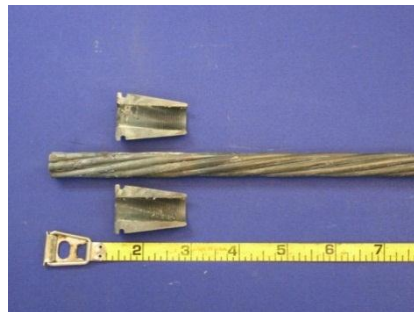
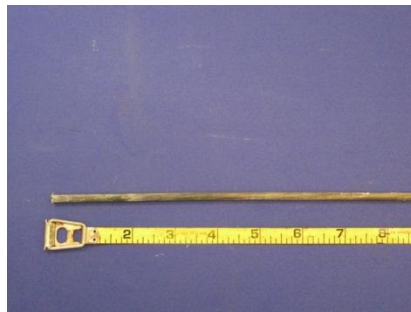
**Figure 5.70: Specimen 3.1 Dead End Anchorage Region Elements**

The outside of both the north and south ducts showed the same chalky white residue which was found on the ducts in the main autopsy region. In addition, prominent corrosion stains were found on the outer surface of the ducts where they had been spliced with the anchorages. Some very light gouges were observed in the interior of the south duct. However, the ducts were moderately damaged during the autopsy process, so the damage may have occurred at that time. The bottom interior surfaces of both ducts showed traces of the white crystals which were found in the main autopsy regions, but to a much lesser extent. North and south ducts are shown in Figure 5.70. Dead end anchorage zone duct corrosion ratings are shown in Figure 5.73 and summarized in Table 5.16.

Both the north and south tendon grout had small voids corresponding to the top of the transverse duct flutes. Heavy corrosion staining was visible on the edge of the grout nearest to the corroded anchorage-duct splices. Both grouts were damaged during the duct removal process, so the extent of cracking could not be determined. North and south grouts are shown in Figure 5.70.

Damage to the strands in both ducts was most severe in the regions outside the anchor head and inside the wedges. Light to moderate surface corrosion spots were found on several outer wires per strand in these regions. Further into the specimen, the outer wires were far less damaged, showing light discoloration and the occasional light corrosion spot. The inner wires of all strands were much more uniformly damaged, with light surface corrosion spots on most intervals. All 6 sets of wedges showed light to moderate corrosion on their outer surfaces and some discoloration spots inside. Damage to the wedges tended to be more extreme near their narrow end. Typical strands, with and without wedges, are shown in Figure 5.70. Dead end anchorage zone strand corrosion ratings are shown in Figure 5.73 and summarized in Table 5.16.

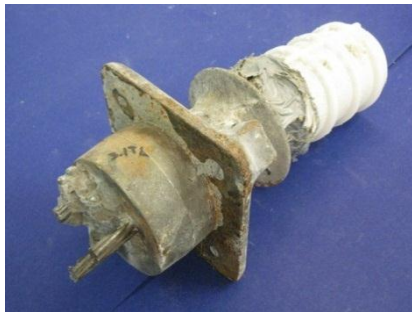
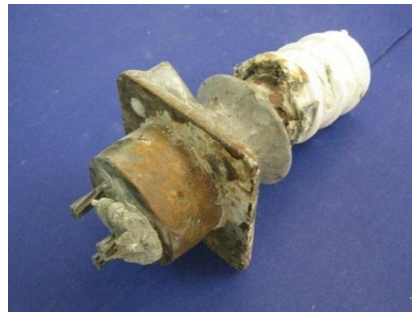
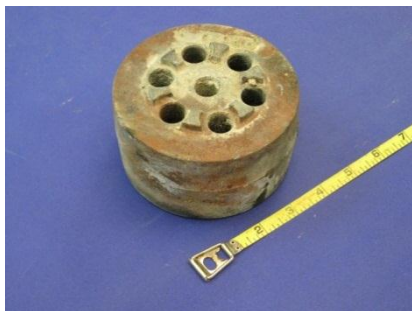
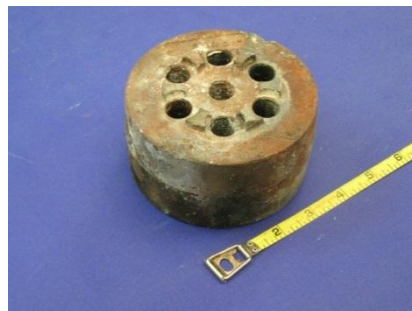
***Figure 5.71: Specimen 3.1 Live End Anchorages and Anchor Heads***

The epoxy used to seal the exposed surfaces of both live end anchorages was almost entirely missing. The exposed front of the bearing plates were mostly covered with widespread moderate surface corrosion and some localized pitting. This damage tended to be more severe toward the bottom of the bearing plates. All outer surfaces showed some isolated surface corrosion, but widespread surface corrosion was found on the bottom surfaces of both bearing plates. This was most pronounced on the north bearing plate, whose bottom surface was nearly covered with corrosion. Some isolated damage occurred on the interior edges of both bearing plates, as well. The duct tape used to seal the bearing plate-duct connections was mostly intact on the north anchorage but mostly missing on the south anchorage. Heavy corrosion and some pitting were found underneath the duct tape. The inside surfaces of both anchor heads showed widespread moderate to heavy corrosion, while the outside surfaces were only slightly discolored. Corrosion on the sides of the anchor heads was more severe in the vicinity of the bearing plates. North and south anchorages and anchor heads are shown in Figure 5.71.

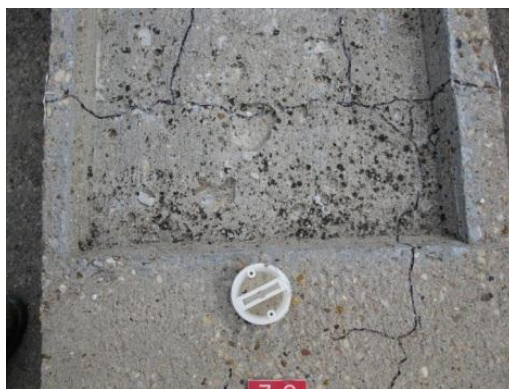
The specimen was lightly to moderately scaled on its top, north, and south faces. Damage was most severe in and around the saltwater tray. Large, shallow surface air voids were visible on the surface of the saltwater tray. Many of those near the grout vents appear to have been “patched” by spilled grout. Numerous small popouts were present in the saltwater tray. Many contained a powdery black residue which could have been a microbial or fungal growth, as shown in Figure 5.75. No signs of corrosion were visible on the surface of the specimen.

**Figure 5.75: Specimen 3.2, Black Residue in Saltwater Tray**
